## **SAFETY NOTICE**

Regarding Roth Solar Panel, type Heliostar 252/252 S4 and 218/218 S4 manufactured in the period from 01/2008 until 05/2011 and sold up until 05/2012.

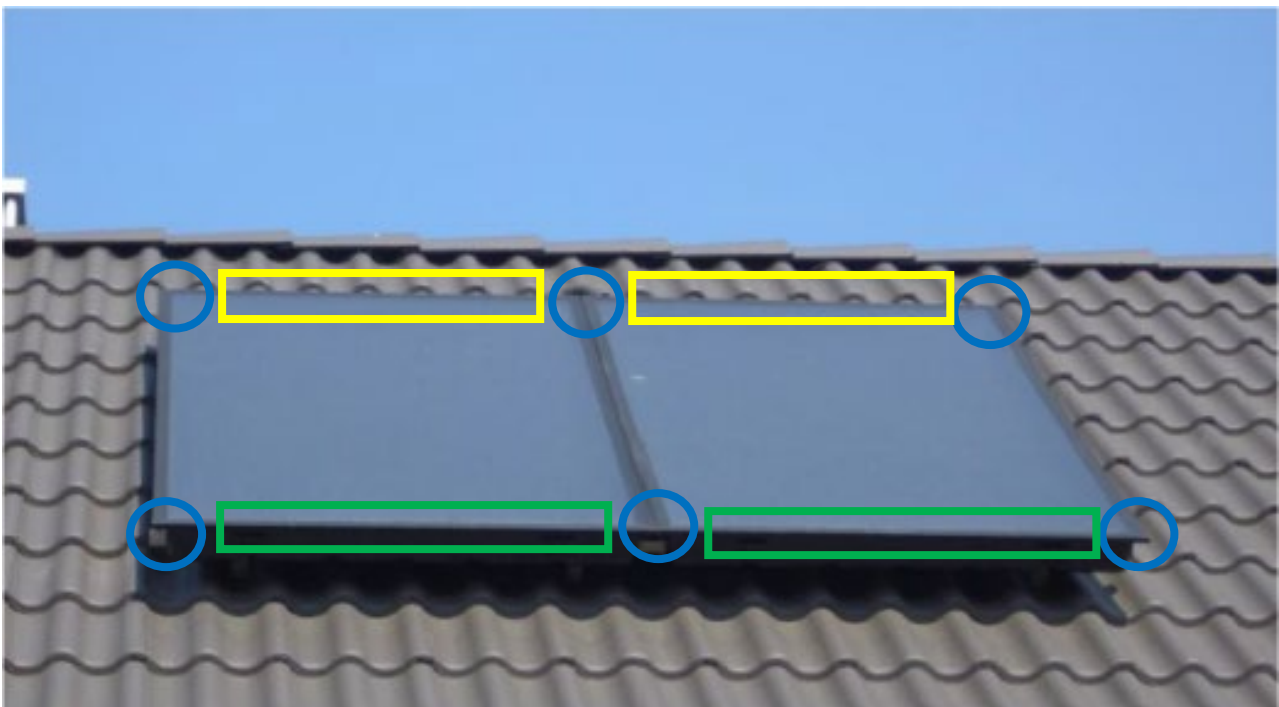
The areas to be checked are as follows:

- The corners/mitter cuts (blue marking)
- The bottom aluminium frame (green marking)
- The top part of the solar panel (yellow marking)

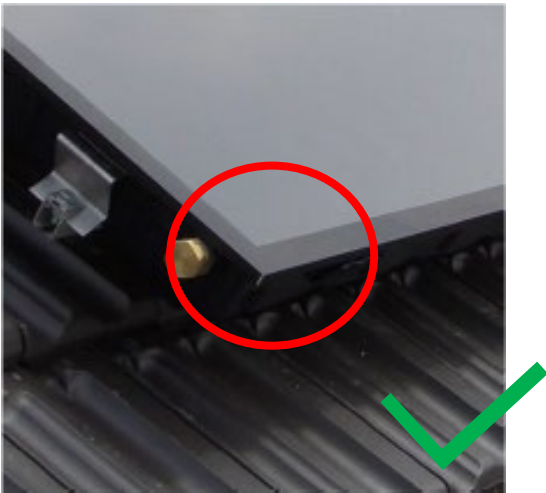
Picture 1

An early indication that further action could be required is that a corner joint of the aluminium frame has opened (For reference see pictures 3 and 4)

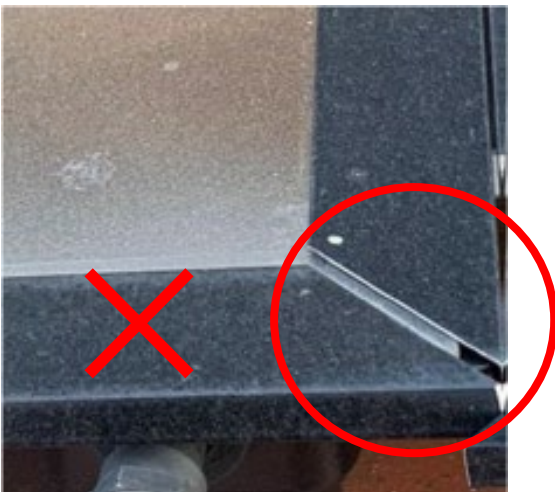
Picture 3

This could, if not detected over time, lead to the glass on the panel coming loose, with the risk of the glass sliding down the panel (see pictures 3, 4, 5 and 6). As far as we can tell these changes happen very slowly, and by conducting maintenance on a regular basis, the changes will be visible long before any critical failure occurs.

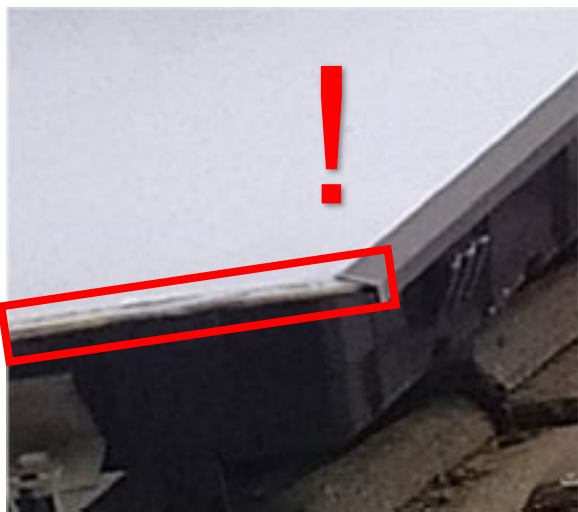
Picture 5

The bottom part of the aluminium frame has come loose or has already fallen off. If the aluminium frame falls off, it will rarely fall to the ground but will instead, due to its geometry and low weight, end up in the gutter or stay on the roof structure. This will make it hard to detect as the frame will not be on the ground, but the changes can easily be seen through binoculars, a camera, or similar devices (For reference see pictures 5 and 6).

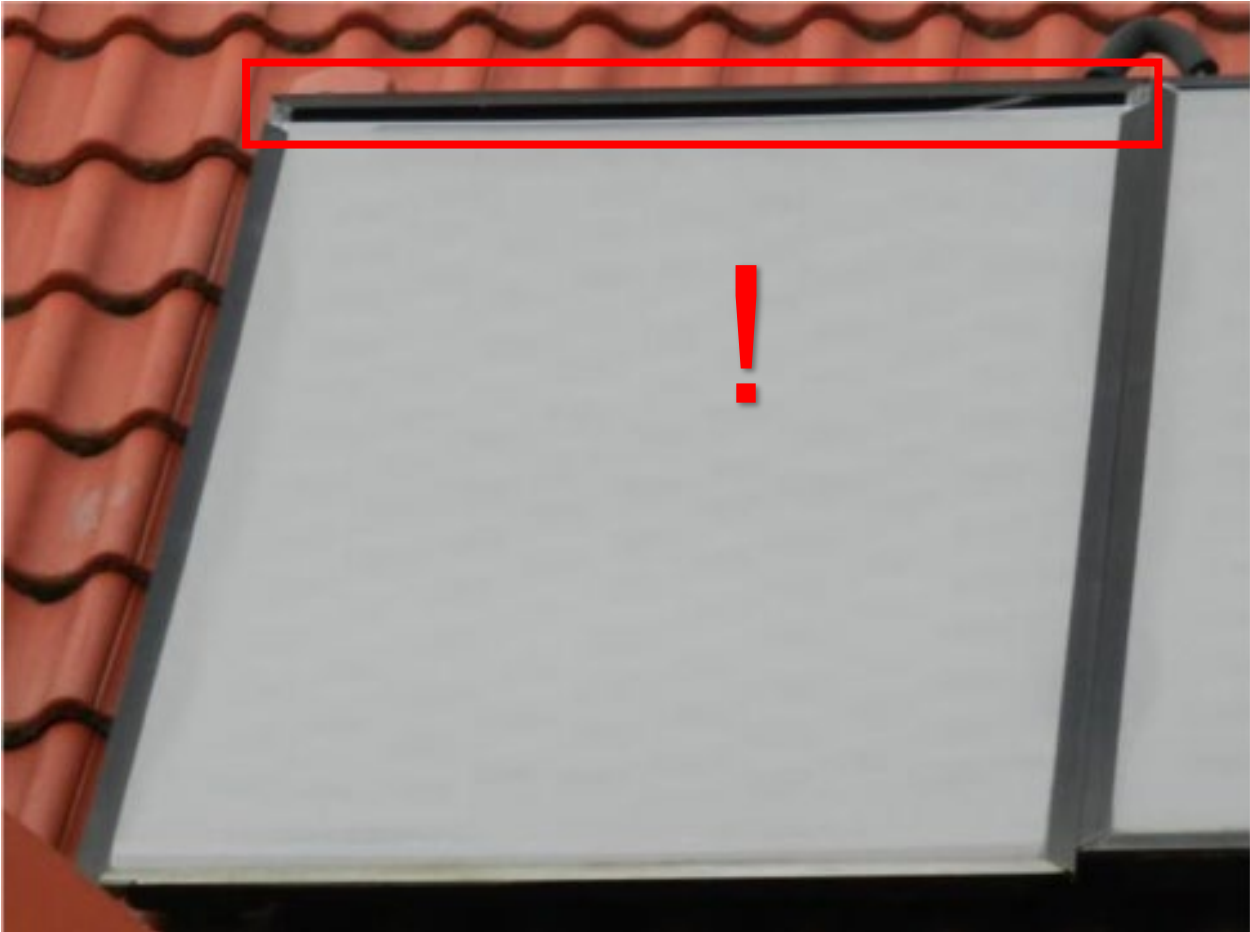
Picture 7

The clearest indication of a possible flaw in the solar panel is that the glass has slid down making a visible hole/crack on the top part of the solar panel. (For reference see picture 7)

**If changes on the solar panel consistent with picture 7 are detected the solar panel must be taken out of operation and secured safely by a competent person (your attention is drawn to the warnings above regarding working at height) - or the area at ground level below the panel should be taken out of use - until remediation has been performed. Fastening brackets and assembly instructions are available free of charge should remediation be required and can be obtained by contacting us as follows: [graham.moore@roth-uk.com](mailto:graham.moore@roth-uk.com) or telephone: 01905453424**
