## **SAFETY NOTICE**

Regarding Roth Solar Panel, type Heliostar 252/252 S4 and 218/218 S4 manufactured in the period from 01/2008 until 05/2011 and sold up until 05/2012.

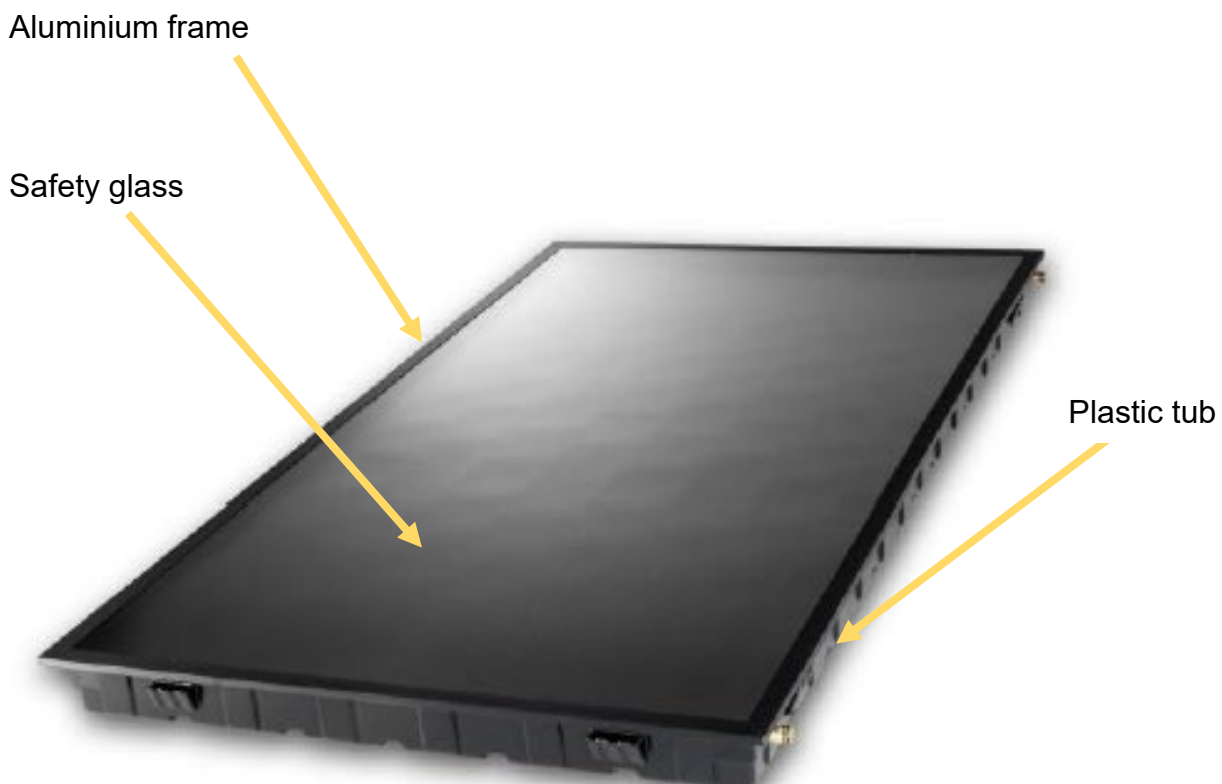
The Roth Heliostar solar panel consists of a plastic tub with a “sun catcher” inside and a glued on solar cell glass made of hardened safety glass. An aluminium frame is glued all around the plastic tub to protect the panel from water and other external factors.
